A-Z Home Inspections  
#29-7179 201 Street  
Langley, B.C. V2Y 2Y9  
License 51393  
778-888-4893

# Home Inspection Report

14171 59A Avenue  
Surrey, B.C. V3X 1C6

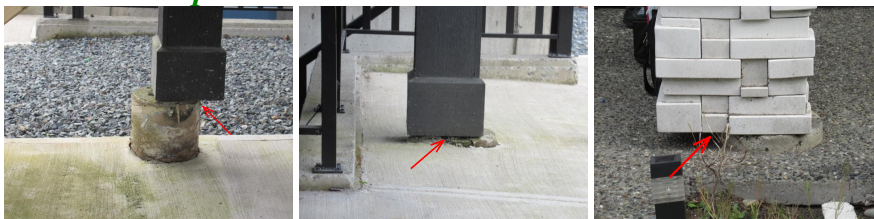
4. Marginal Support Posts & Piers: **Concrete piers and wood posts, Support posts not centered on piers.**

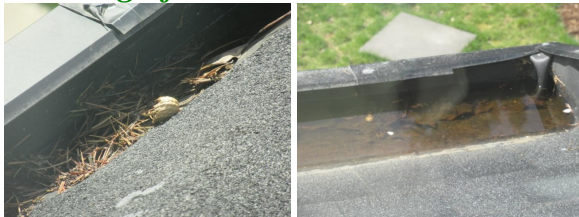
1. Approximate Age: **1-5 years,**
2. Satisfactory Roof Visibility: **Viewed from ground, (inspection limited),**
3. Satisfactory Style of Roof & Pitch: **Gable,, Steep pitch,**
4. Satisfactory Type of Surface Material: **Asphalt shingle,**
5. Satisfactory Ventilation System: **Soffit & roof vents,**
6. Satisfactory Flashings: **Galvanized metal,**
7. Not Present Skylights:
8. Satisfactory Plumbing Vents: **ABS piping,**
9. Marginal Gutters/Eavestroughs: **Hidden gutters with rubber membrane, Gutters need cleaning of debris.**

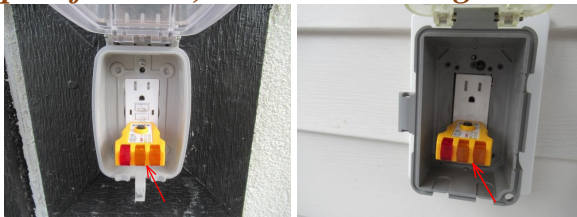
17. Poor Exterior Electric Outlets: *110 Volt GFCI, Inoperative at time of inspection. GFCI outlet was off and does not reset. Basement entry outlet had stiff tamper proof covers, was not able to get tester inside.*

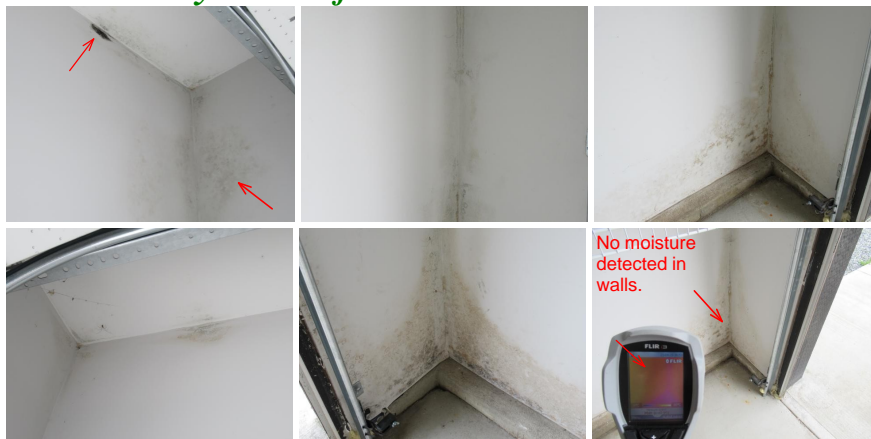
- 2. **Satisfactory** Car Spaces: **2 Car,**
- 3. **Satisfactory** Overhead Door: **Metal,**
- 4. **Satisfactory** Automatic Opener: **Operable,**
- 5. **Satisfactory** Safety Reverse: **Electric beam & pressure reverse,**
- 6. **Satisfactory** Roof: **Asphalt shingle,**
- 7. **Satisfactory** Gutters/Downspouts: **Aluminum,**
- 8. **Satisfactory** Siding/Trim: **Vinyl,**
- 9. **Satisfactory** Floor/Foundation: **Poured concrete,**
- 10. **Satisfactory** Sill Plates: **Elevated,**
- 11. **Satisfactory** Exterior Service Doors: **Metal,**
- 12. **Not Present** Windows:
- 13. **Satisfactory** Electrical: **110 Volt lighting and receptacles,**
- 14. **Not Present** Heating:
- 15. **Marginal** Fire Separation Walls and Ceilings: **Painted surfaces, *Appears to be mould on drywall surfaces near overhead door.***

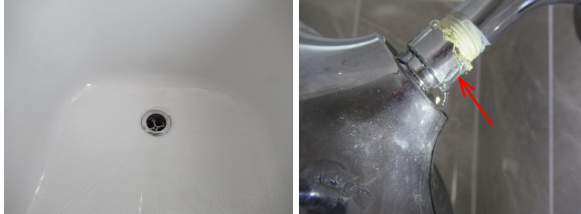
40. **Satisfactory** Water Shut Off Valves: *Visible,*  
41. **Marginal** Tub/Shower Faucets: *Chrome fixtures, Tub stopper was missing., Showerhead was dripping.*

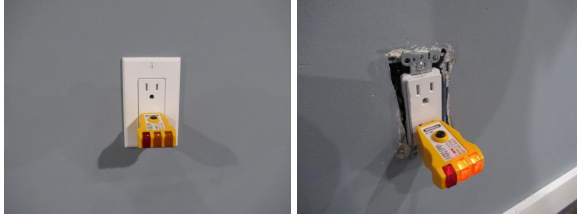
19. **Satisfactory** Walls and Ceilings: *Painted surfaces,*
20. **Satisfactory** Flooring: *Carpet,*
21. **Marginal** Electrical: *110 Volt lighting and receptacles, No power at upper TV outlet , Missing outlet/switch cover plates.*

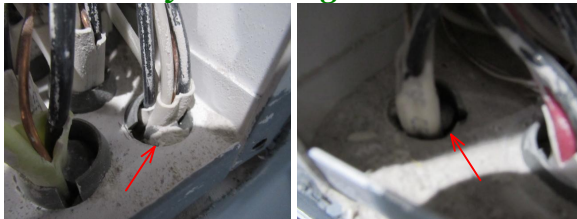
2. Service Amps: 125A Volts: 110-240 VAC
3. Satisfactory Main Breaker Size: 125 Amps,
4. Satisfactory Overcurrent Protection:: Circuit Breakers,
5. Satisfactory Adequate Clearance to Panel: Panel was readily accessible,
6. Satisfactory Panel Cover/Cabinet: No missing components,
7. Satisfactory Panel Grounded: Ground was visible inside electrical panel,
8. Satisfactory Panel Bonded: Bond NOT visible between Neutral & Ground conductors,
9. Satisfactory Main Service Conductors: Aluminum,
10. Marginal Branch Wiring Conductors: Copper and stranded aluminum (typical), Two connectors not installed correctly. No harm however best practice not observed by installing electrician.

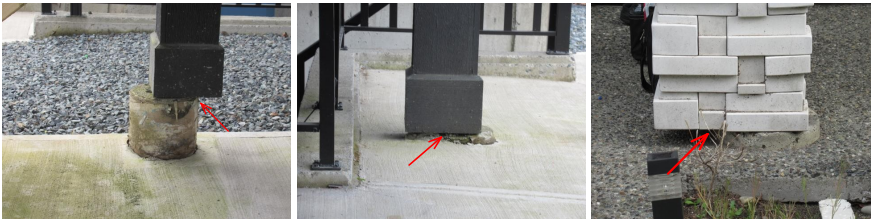
1. Support Posts & Piers: *Concrete piers and wood posts, Support posts not centered on piers.*

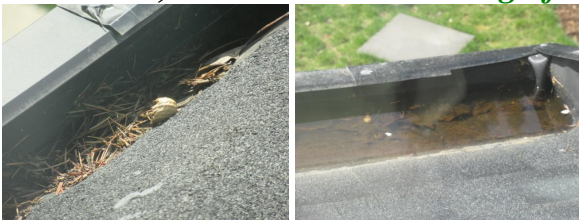
3. Main House: Roof Surface Gutters/Eavestroughs: *Hidden gutters with rubber membrane, Gutters need cleaning of debris.*

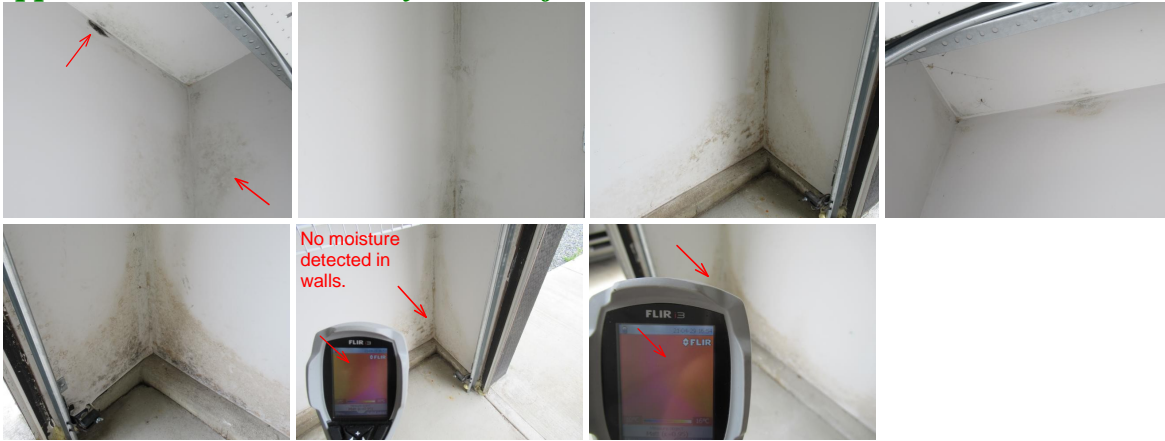
7. Detached:, On Grade: Garage Fire Separation Walls and Ceilings: ***Painted surfaces, Appears to be mould on drywall surfaces near overhead door.***

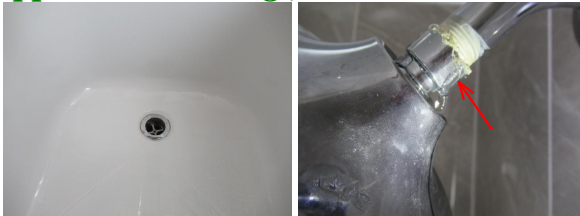
20. Upper East Ensuite, 4 Piece: Bathroom Tub/Shower Faucets: **Chrome fixtures, Tub**  
**stopper was missing., Showerhead was dripping.**

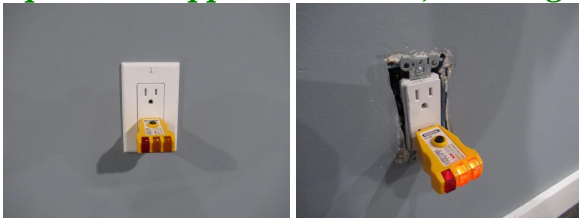
29. Basement Theatre Room: Living Space Electrical: *110 Volt lighting and receptacles, No power at upper TV outlet , Missing outlet/switch cover plates.*

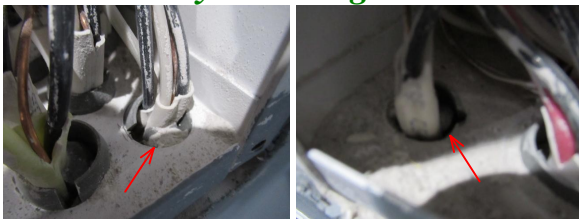
32. Basement: Electric Panel Branch Wiring Conductors: *Copper and stranded aluminum (typical), Two connectors not installed correctly. No harm however best practice not observed by installing electrician.*

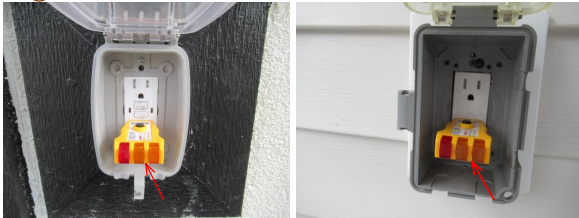
1. Exterior Electric Outlets: ***110 Volt GFCI, Inoperative at time of inspection. GFCI outlet was off and does not reset. Basement entry outlet had stiff tamper proof covers, was not able to get tester inside.***
