A-Z Home Inspections
#29-7179 201 Street
Langley, B.C. V2Y 2Y9
License 51393
778-888-4893

Home Inspection Report

123 Main Street
Anywhere, B.C. V1V 2M2

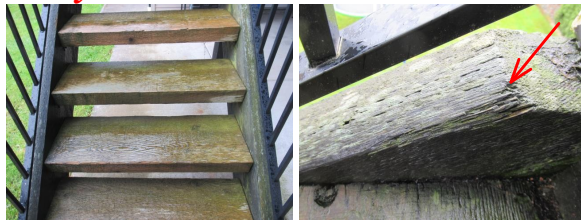
5. Safety Exterior Steps & Handrails: **Wood steps,, Metal handrails, Stair treads**
were very slippery, recommend anti slip device. Top of stair stringer had some
decay.

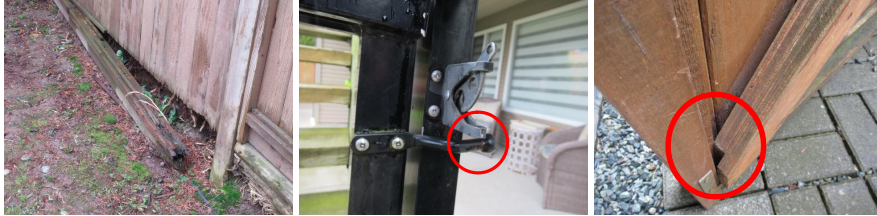
9. Marginal Fence/Gates: *Metal,, Wood, Fence had damaged areas, loose components on gate, some decay and missing post caps. Lower staircase gate was sagging from attachment to handrail, latch was not aligned.*

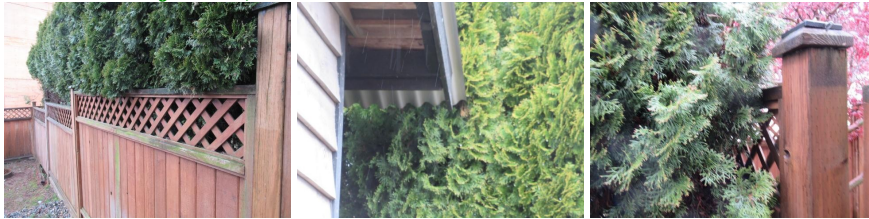
10. Marginal Landscaping Near Foundation: *Trees & shrubs, Keep vegetation from contact to fence, house and shed.*

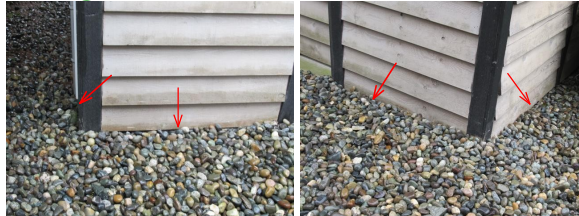
11. Satisfactory, Marginal Grading: *Soil was high, soil contacts siding, Soil contacts shed wood siding.*

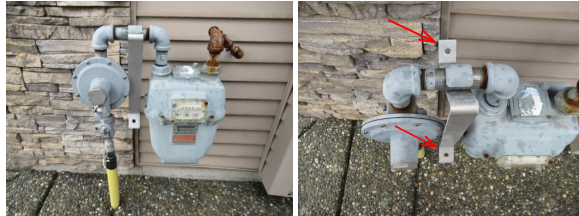
15. Satisfactory, Marginal Gas Meter: *South,, Exterior, Retaining clamp was not fastened to house.*

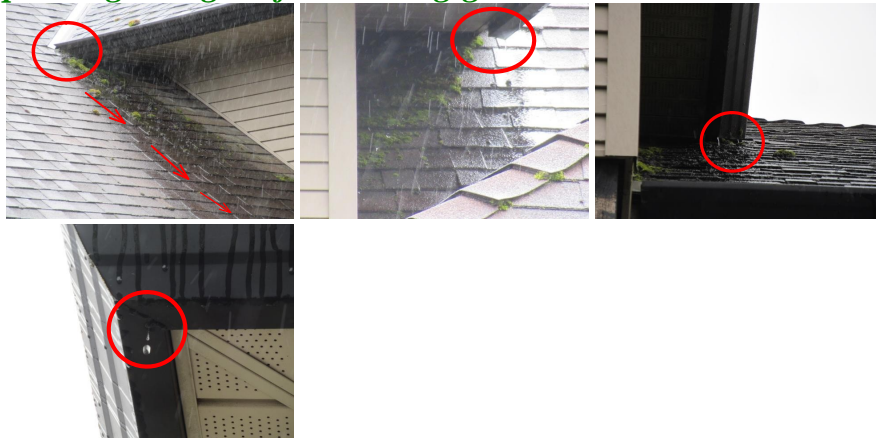
1. *Satisfactory, Marginal* Gutters/Eavestroughs: *Aluminum, Upper roof gutters drain to lower roof shingles, recommend flashings to lower gutters to help prolong shingle life. Leaking gutter corner SW.*

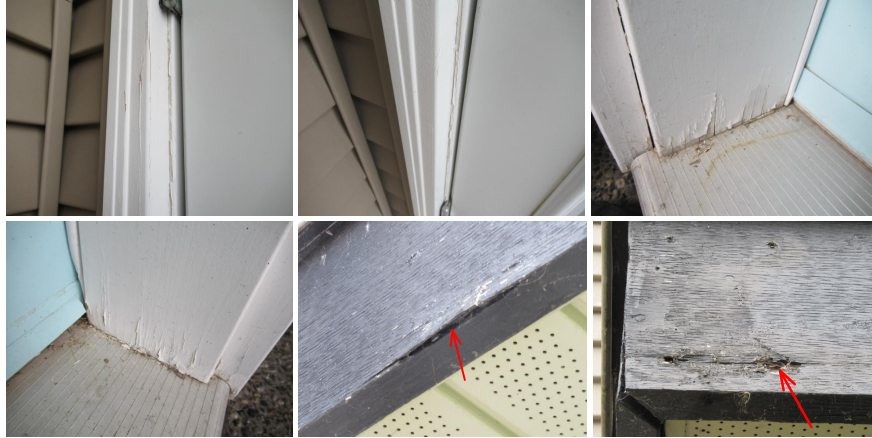
4. *Satisfactory, Marginal* Trim: Wood, *Minor flaking paint visible in areas. Balcony wood trim had some damaged wood visible.*

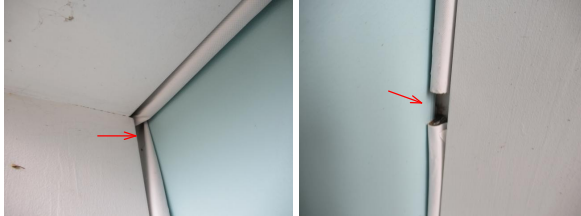
13. Satisfactory Exterior Door Weatherstrip: *Foam/plastic in door channel, **Minor gaps visible.***

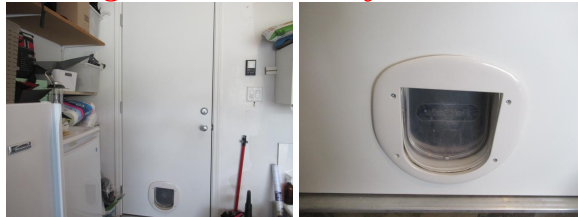
11. Not Present Heating: *None visible,*
12. Satisfactory Fire Separation Walls and Ceilings: *Painted surfaces,*
13. Safety Garage/House Entry Door: *Metal, Pet door cut through metal house door, no longer considered a fire door.*

14. Safety Auto Closure Device: *Not present, Recommend auto closure device on house entry door.*

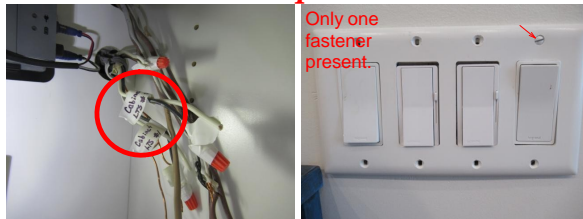
5. Safety Electrical: *110 Volt lighting and receptacles, Disposal was removed, several live wires in cabinet not terminated in junction box. Missing fasteners on wall multi switch cover plate.*

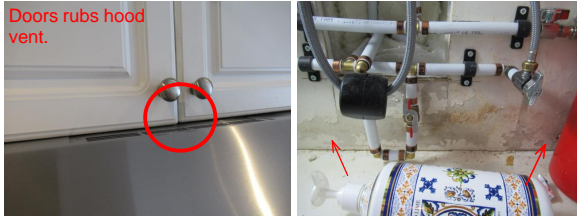
19. Marginal Cabinets: *Laminated Wood, Cabinet doors rub hood vent. Moisture damage in sink cabinet.*

Doors rubs hood vent.

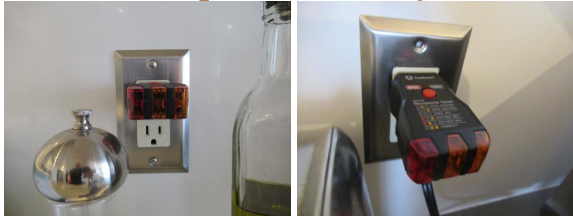
21. Satisfactory, Poor Electrical: *110 Volt lighting and receptacles, Several counter top outlets did not have power at 1/2 of outlet.*

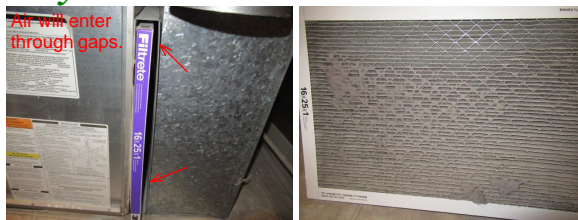
9. Marginal Furnace Filter: **Paper filter, Recommend filter cover, not present., Filter was dirty.**

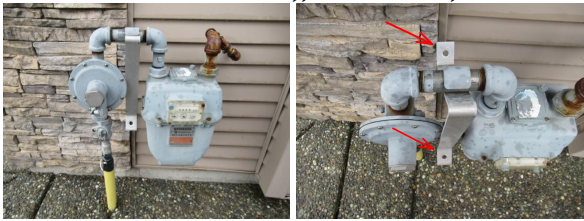
7. Gas Meter: *South,, Exterior, Retaining clamp was not fastened to house.*

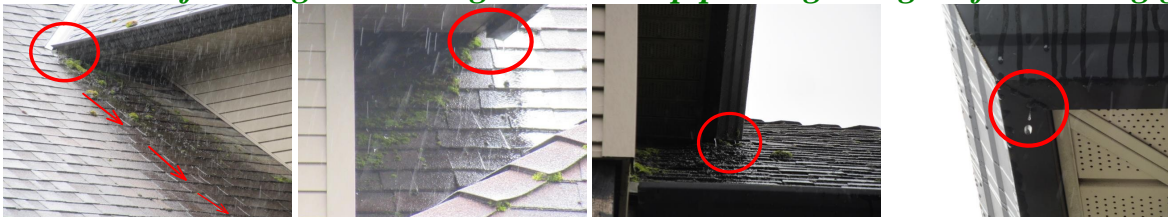
9. Gutters/Eavestroughs: *Aluminum, Upper roof gutters drain to lower roof shingles, recommend flashings to lower gutters to help prolong shingle life. Leaking gutter corner SW.*

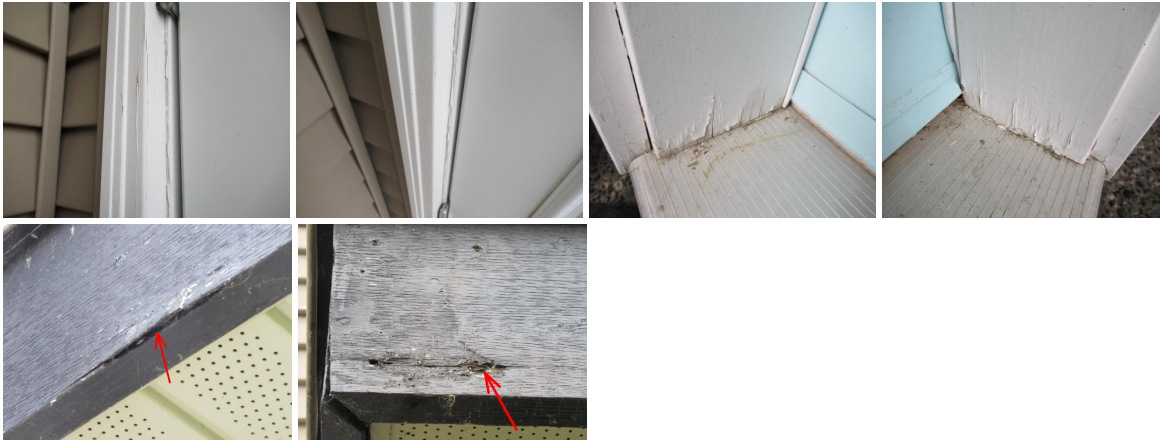
12. Trim: **Wood**, *Minor flaking paint visible in areas. Balcony wood trim had some damaged wood visible.*

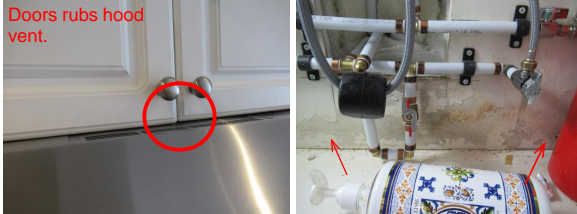
15. Basement suite: Kitchen Cabinets: **Laminated Wood**, **Cabinet doors rub hood vent.**
Moisture damage in sink cabinet.

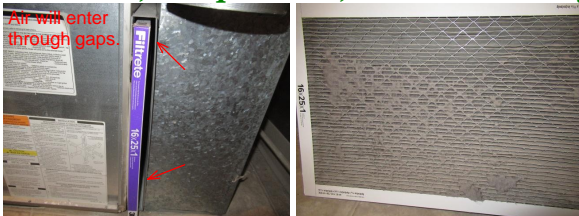
29. Basement Utility Area: Heating System Furnace Filter: *Paper filter, **Recommend filter cover, not present., Filter was dirty.***

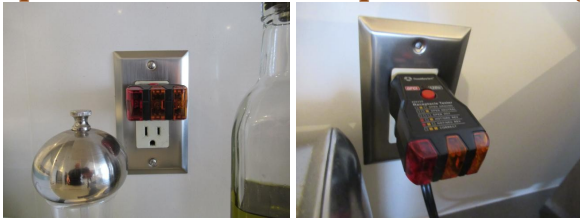
1. Basement suite: Kitchen Electrical: *110 Volt lighting and receptacles, Several counter top outlets did not have power at 1/2 of outlet.*

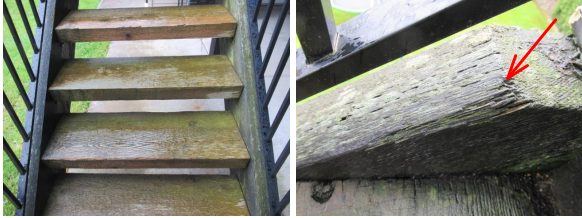
1. Exterior Steps & Handrails: **Wood steps,, Metal handrails, Stair treads were very slippery, recommend anti slip device. Top of stair stringer had some decay.**

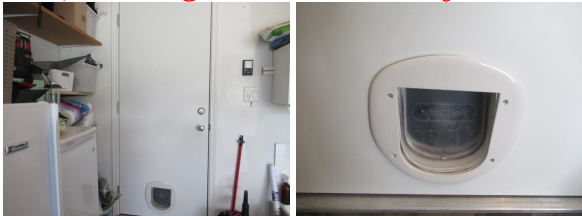
2. Attached: Garage Garage/House Entry Door: **Metal, Pet door cut through metal house door, no longer considered a fire door.**

3. Attached: Garage Auto Closure Device: **Not present, Recommend auto closure device on house entry door.**

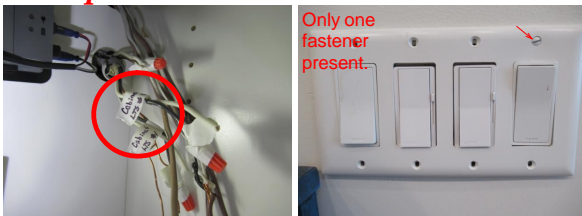
4. Main: Kitchen Electrical: **110 Volt lighting and receptacles, Disposal was removed, several live wires in cabinet not terminated in junction box. Missing fasteners on wall multi switch cover plate.**
