A-Z Home Inspections  
#29-7179 201 Street  
Langley, B.C. V2Y 2Y9  
License 51393  
778-888-4893

# Home Inspection Report

14171 59A Avenue  
Surrey, B.C. V3X 1C6

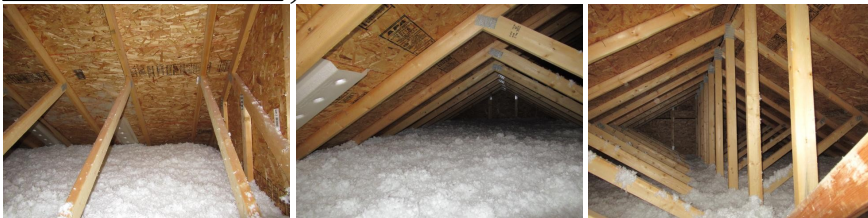
1. General Photos: ,

2. Method of Inspection: *From the attic access,*

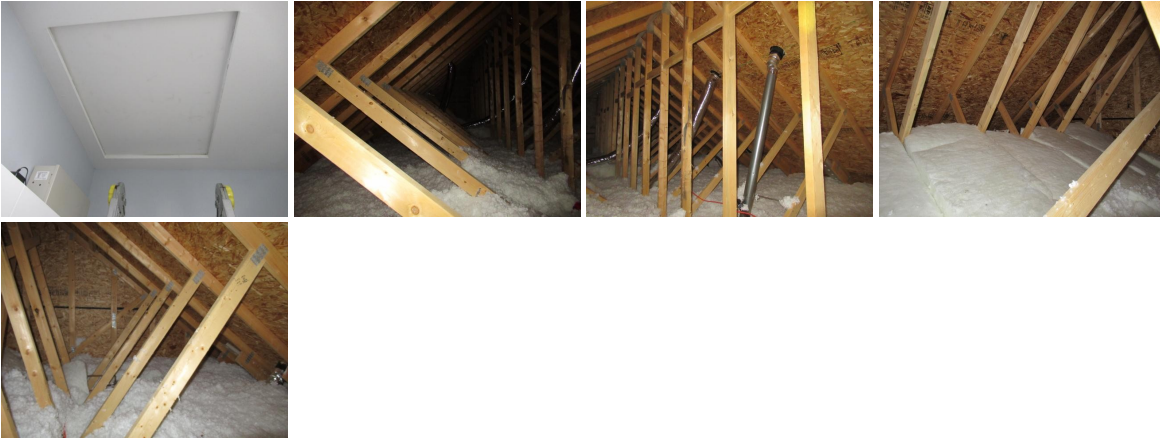
12. General Photos: ,

13. Method of Inspection: **From the attic access,**

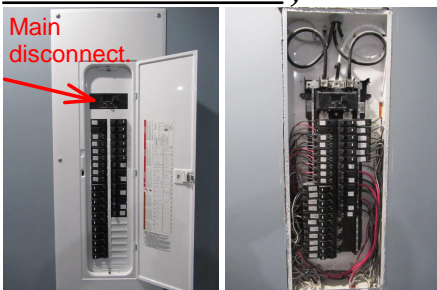
1. General Photos: ,

2. Service Amps: 125A Volts: 110-240 VAC
3. Satisfactory Main Breaker Size: 125 Amps,
4. Satisfactory Overcurrent Protection:: Circuit Breakers,
5. Satisfactory Adequate Clearance to Panel: Panel was readily accessible,
6. Satisfactory Panel Cover/Cabinet: No missing components,
7. Satisfactory Panel Grounded: Ground was visible inside electrical panel,
8. Satisfactory Panel Bonded: Bond NOT visible between Neutral & Ground conductors,
9. Satisfactory Main Service Conductors: Aluminum,
10. Marginal Branch Wiring Conductors: Copper and stranded aluminum (typical), Two connectors not installed correctly. No harm however best practice not observed by installing electrician.

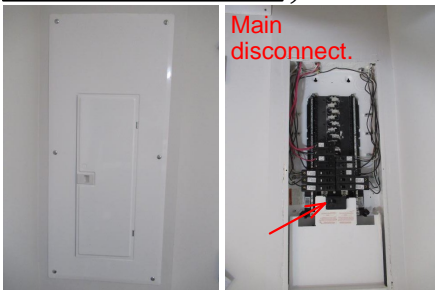
14. General Photos: ,

15. Service Amps: 100A Volts: 110-240 VAC
16. Satisfactory Main Breaker Size: 100 Amps,
17. Satisfactory Overcurrent Protection:: Circuit Breakers,
18. Satisfactory Adequate Clearance to Panel: Panel was readily accessible,
19. Satisfactory Panel Cover/Cabinet: No missing components,
20. Satisfactory Panel Grounded: Ground was visible inside electrical panel,
