A-Z Home Inspections
#29-7179 201 Street
Langley, B.C. V2Y 2Y9
License 51393
778-888-4893

Home Inspection Report

123 Main Street
Anywhere, B.C. V1V 2M2

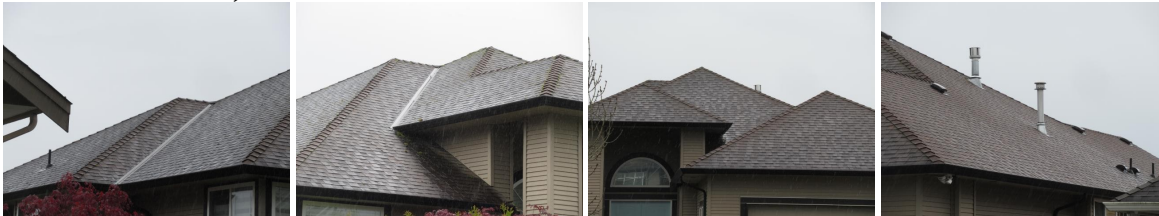
1. Roof Photos: ,

2. Approximate Age: *15-20 years,*

3. Satisfactory, Marginal Roof Visibility: *Viewed from ground, (inspection limited), Weather and pitch may restrict access.*

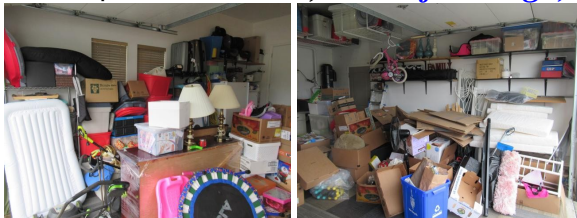
2. Satisfactory Car Spaces: *2 Car, Full of storage, blocked views and access to areas.*
